PHARM025: Observation of Abnormalities in Laminated Film

Introduction

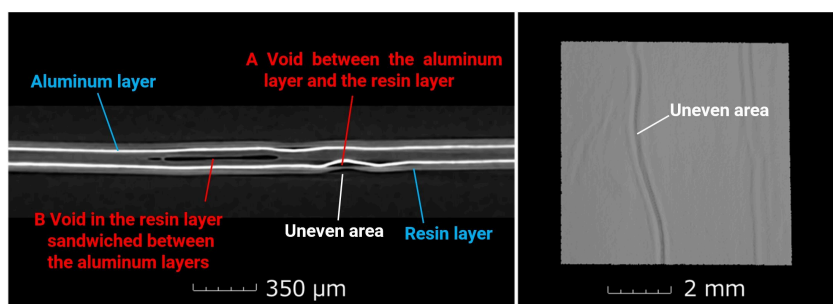
Figure 1: Cross-section and 3D images of aluminum laminated film

Figure 1 shows CT cross-sectional and three-dimensional images of an aluminum laminate film in an uneven area. In area A, a void was observed between the aluminum layer (white) and the resin layer (gray), and in area B, a void was observed in the resin layer sandwiched between the aluminum layers. In addition, the resin layer on the top surface of the uneven area is approximately one-third thinner than the normal area. In this way, micro X-ray CT can clearly and nondestructively visualize the internal defect structure of the film, which cannot be identified from the external appearance.
