XRI1001 - CT observation of a laminated battery cell by X-ray microscopy

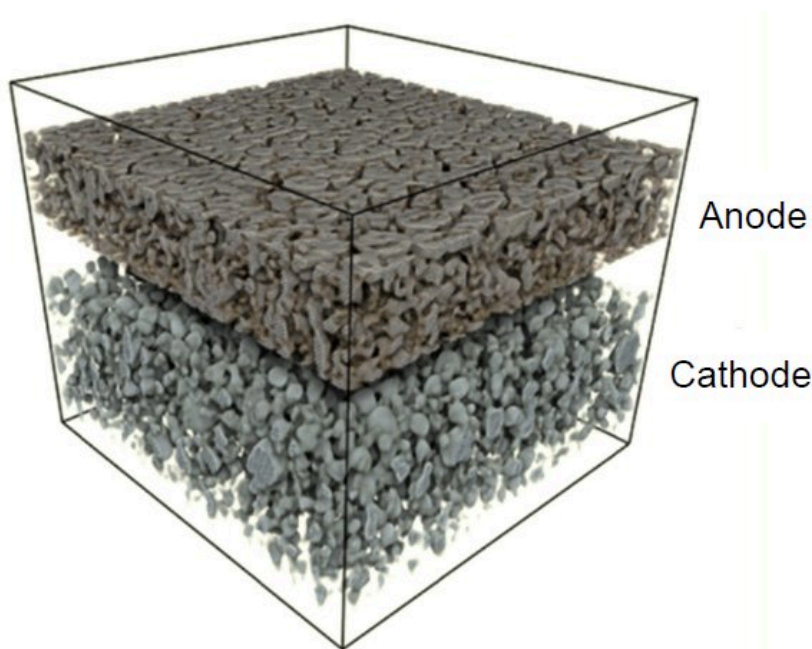
Figure 1: X-ray CT 3D rendering image 1.08 $\mu\text{m}/\text{voxel}$

A CT measurement was performed using the nano3DX X-ray microscope on a 10 mm wide single-layer lithium ion battery cell laminated with aluminum (Figures 1 and 2). As a result, the active materials and carbon particles within the battery cell were clearly rendered. Structural changes during charging and discharging can also be observed in a non-destructive manner by attaching an electrode to the laminated cell.

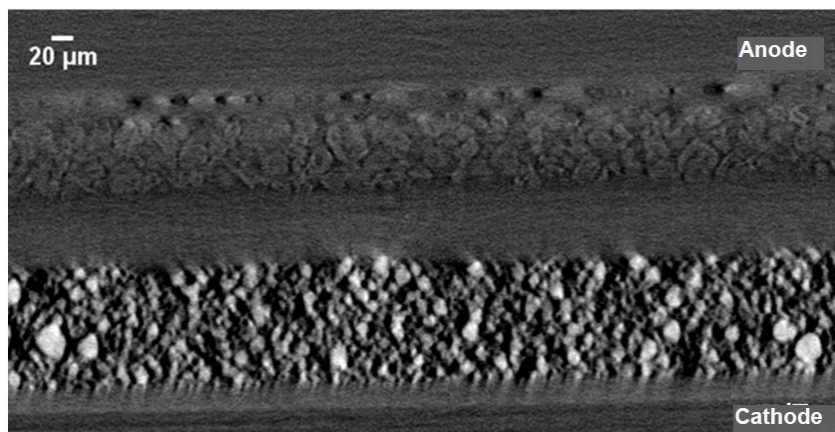
Figure 2: X-ray CT Tomography image 1.08 $\mu\text{m}/\text{voxel}$

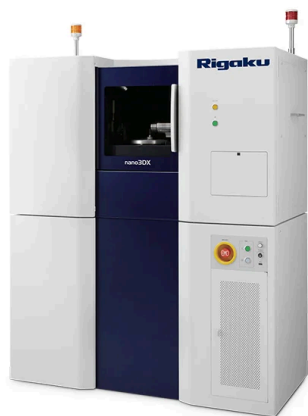
nano3DX

Ultrahigh resolution nanotomography using parallel beam geometry
