Makeup Sponge Wear and Tear Analysis by X-ray CT

About the sample: Cosmetic blender sponge

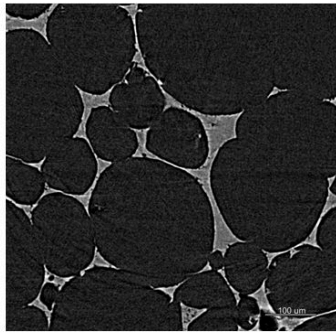
Brand new

The gray level in CT images represents the density of the material. Light gray and dark gray represent the polymer and air, respectively. The brand new sponge shows intact round-shaped cells. Meanwhile, the one after 7-month of use appears crumbled and no longer holds round-shaped cells. The 7-month old sponge was less elastic and hydrophilic. This

structural change is consistent with these changes in performance.

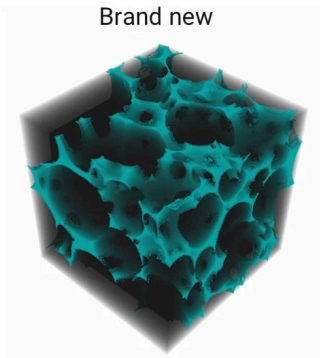
Brand new

The polymer and air were segmented using the [machine learning segmentation](#) method. The wear and tear of the foam structure are clearly seen in the 3D rendered representation of the segmented area. The 7-month old sponge exhibited a significantly lower porosity of 84.4 vol% compared to that of the brand new sponge at 90.7 vol%.

Porosity = 90.7 vol%

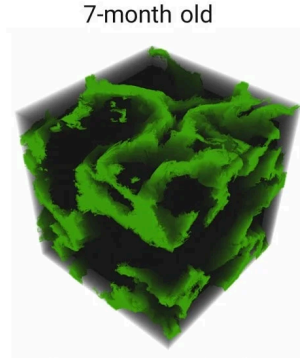
7-month old

Porosity = 84.4 vol%

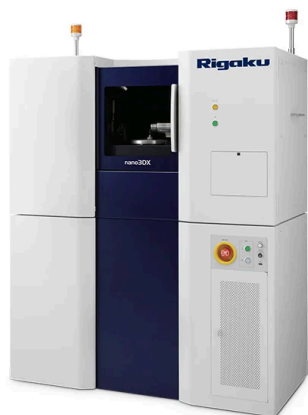
nano3DX

Ultrahigh resolution nanotomography using parallel beam geometry

1. In this example, a piece of makeup sponge was scanned before and after 7-month of use using a submicron-resolution CT scanner, [nano3DX](#).
2. The foam structures were compared from CT cross-sections.
3. The porosities were calculated from segmented CT images.
