Makeup Sponge Wear and Tear Analysis by X-ray CT

About the sample: Cosmetic blender sponge

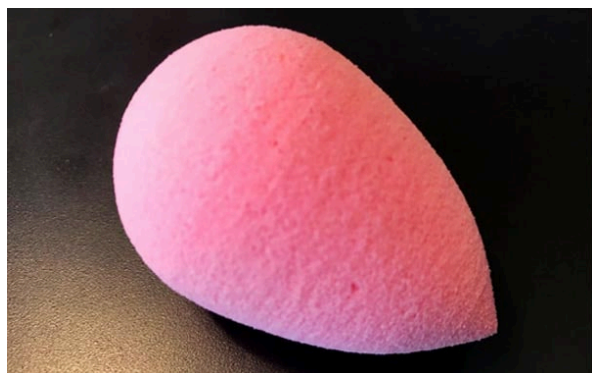
1. CT scan

About a millimeter size piece was removed from a brand new cosmetic blender sponge and was scanned to produce the 3D grayscale CT image. The same experiment was repeated after the sponge was used and washed every day for seven months.

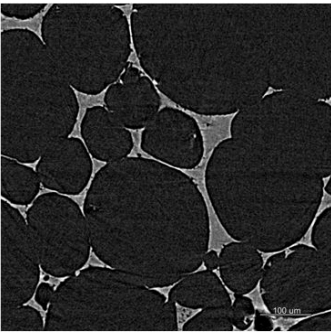
Brand new

The gray level in CT images represents the density of the material. Light gray and dark gray represent the polymer and air, respectively. The brand new sponge shows intact round-shaped cells. Meanwhile, the one after 7-month of use appears crumbled and no longer holds round-shaped cells. The 7-month old sponge was less elastic and hydrophilic. This

structural change is consistent with these changes in performance.

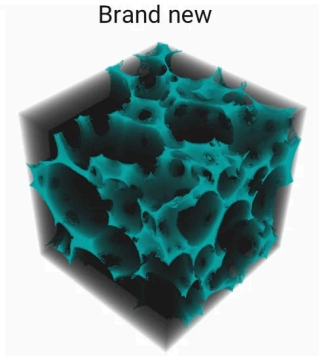
Brand new

The polymer and air were segmented using the [machine learning segmentation](#) method. The wear and tear of the foam structure are clearly seen in the 3D rendered representation of the segmented area. The 7-month old sponge exhibited a significantly lower porosity of 84.4 vol% compared to that of the brand new sponge at 90.7 vol%.

Porosity = 90.7 vol%

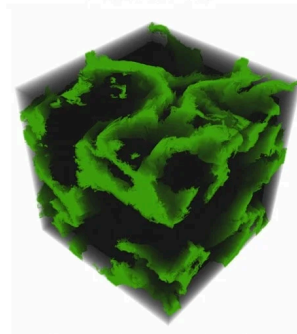
7-month old

Porosity = 84.4 vol%

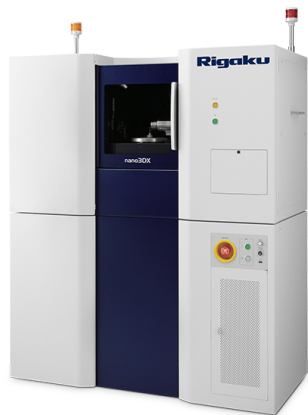
nano3DX

Ultrahigh-resolution nanotomography using parallel beam geometry

1. In this example, a piece of makeup sponge was scanned before and after 7-month of use using a submicron-resolution CT scanner, [nano3DX](#).
2. The foam structures were compared from CT cross-sections.
3. The porosities were calculated from segmented CT images.
