Delamination in Lithium-ion Batteries

About the sample: Batteries

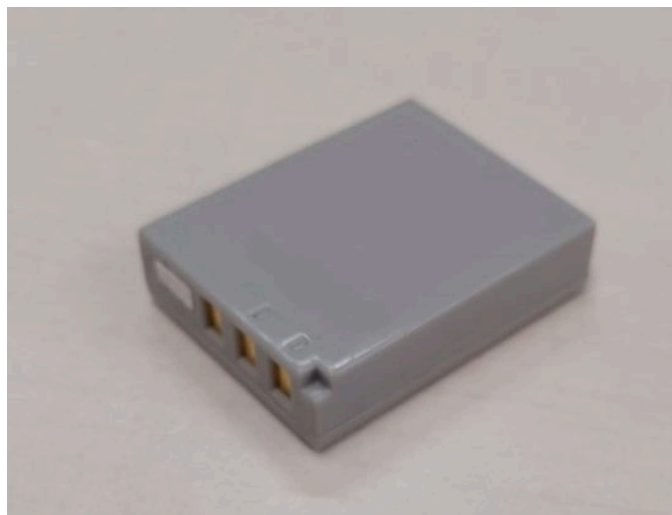
1. CT scan

Two lithium-ion battery packs, normal and damaged, were scanned to produce the 3D grayscale CT images.

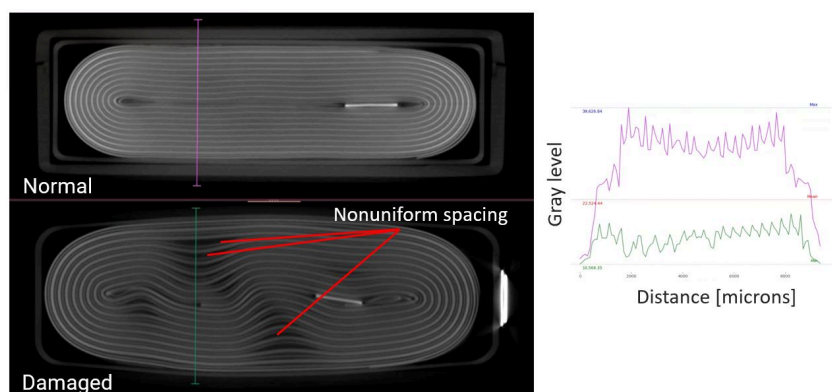
2D cross-sections for the two batteries are shown. The one labeled "damaged" shows signs of swelling and delamination within the battery layers. An intensity plot taken across each battery shows significant nonuniform spacing between layers in the 'damaged' battery.

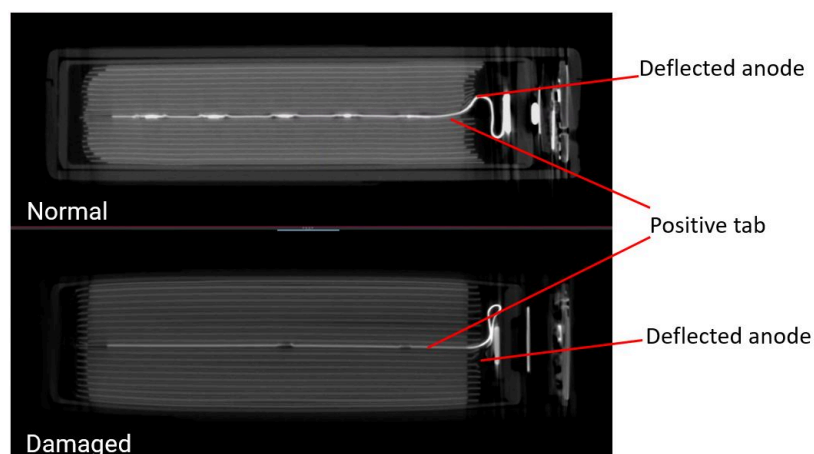
2D cross-sections along the positive tab are shown in the figure. Both the normal functioning and damaged batteries show deflected anodes.

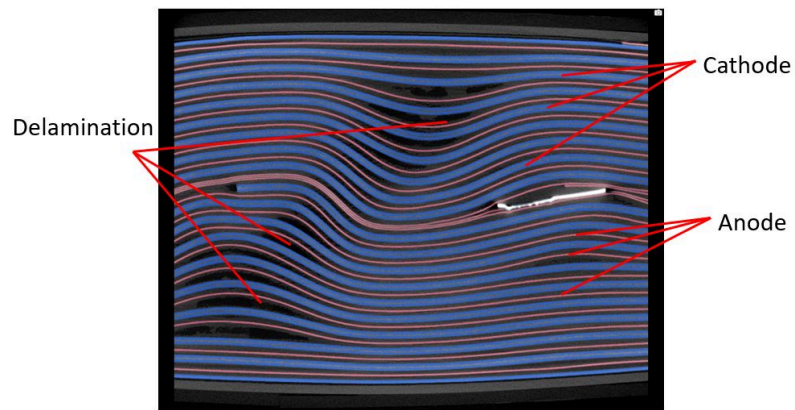
[Deep learning segmentation](#) was performed for the CT image. The cathode is shown in blue and the anode is red. Areas of delamination can be seen in the nonuniform layers as darkened areas.

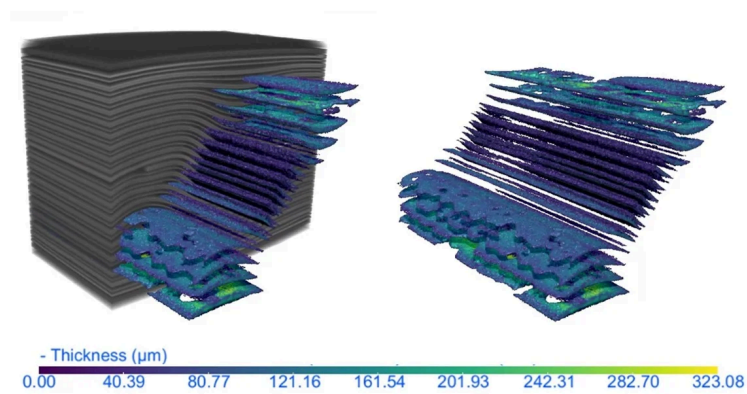
The size distribution of the delamination was calculated. The green and yellow areas indicate over 200 microns wide delamination.
