# POLYMER007: Orientation Analysis of Short Fibers in GFRP

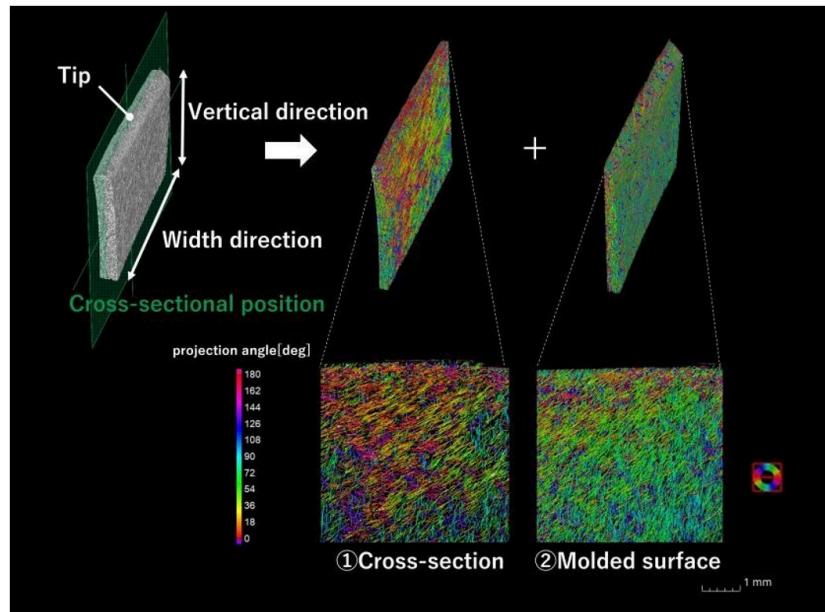
**Figure 1:** Cross-section of fan blade and fiber orientation on molded surface

A GFRP fan blade of approximately 0.6 mm thickness was cut to 10 mm width and CT imaging was performed at 3.6  $\mu\text{m}/\text{voxel}$  for 17 minutes.

(1) In the cross-section, GF was colored red to yellow for about 4 mm from the blade tip, with a predominant orientation in the width direction. (2) On the molded surface, GF was blue to green over a wide area except for about 1 mm from the blade tip, indicating a predominance of vertical orientation.
