POLYMER008: Observation of the Internal Structure of CFRP by in-situ X-ray CT Imaging during Tensile Testing

Non-destructive imaging

Analysis:	Raw materials and parts products
Use:	Process control, failure analysis, quality assurance
Analyzed materials:	Carbon fiber reinforced plastic (CFRP)

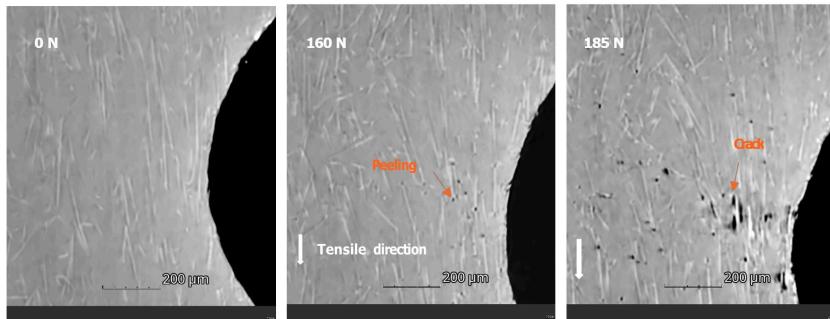
Figure 1: Cross-sectional image of CFRP at each tensile load

Tensile load was progressively applied to the CFRP and in-situ CT imaging was performed for 8 minutes at 160 N of load, delamination occurred at the interface between the carbon fiber and resin, forming a void, and at 185 N, crack initiation was observed starting from the void (Figure 1). Thus, nondestructive visualization of the fracture process made it possible to identify signs of initial damage and interface abnormalities.

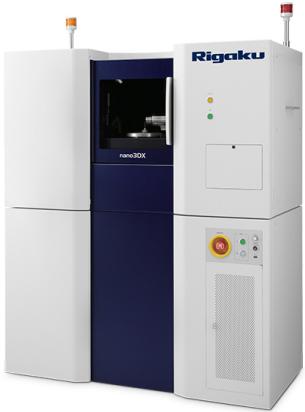
nano3DX

Ultrahigh-resolution nanotomography using parallel beam geometry
